UNDERWATER BRIDGE INSPECTION REPORT

STRUCTURE NO. 7221

VERMILLION RIVER

MINNESOTA DEPARTMENT OF TRANSPORTATION
UNDERWATER BRIDGE INSPECTION

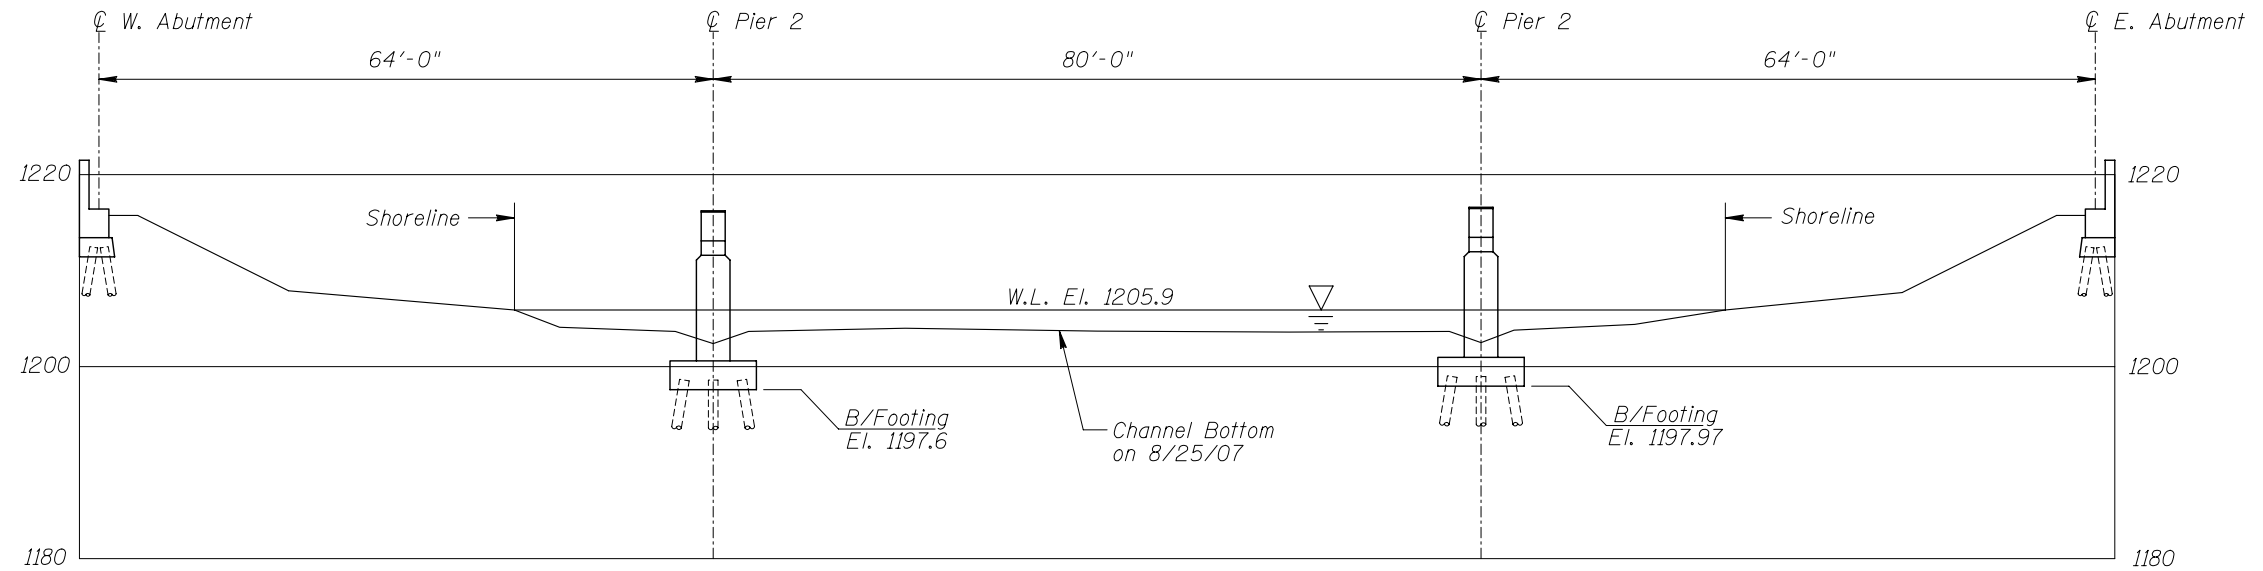
UPSTREAM FASCIA PROFILE

- (A) Scaling was observed from 4 feet above the waterline to 1 foot below the waterline with ½ inch maximum penetration at the upstream and downstream columns of Piers 1 and 2.
- (B) Scour depressions 6 feet in radius by a maximum depth of 2 feet were observed at the upstream and downstream columns of both piers.
- (C) A light accumulation of timber debris consisting of logs up to 10 inch in diameter was located at the upstream column of Pier 2 at the channel bottom.
- (D) A moderate accumulation of timber debris consisting of 1 foot diameter and smaller logs and branches was observed at the upstream column of Pier 1 extending from the channel bottom up 2 feet.
